In-flight engine failure involving Sikorsky S-76C helicopter, VH-EXU

Snapper Platform, Bass Strait (74 km east of Longford, Victoria) | 11 July 2013

ATSB Transport Safety Report
Aviation Occurrence Investigation
AO-2013-124
Final – 20 October 2016

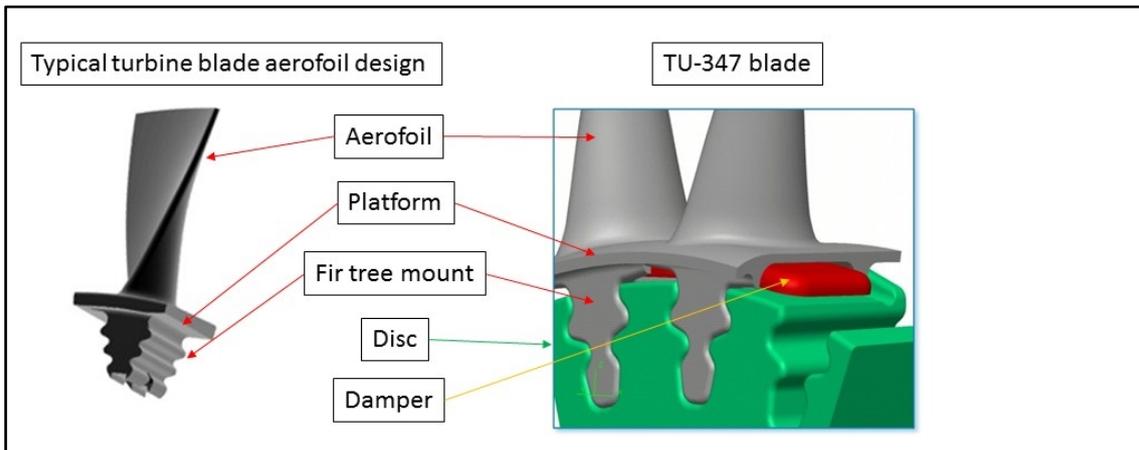
Figure 3: TU-347 detail

The HP2 turbine of the right engine in EXU had TU-347 incorporated when the Module 3 was last overhauled.

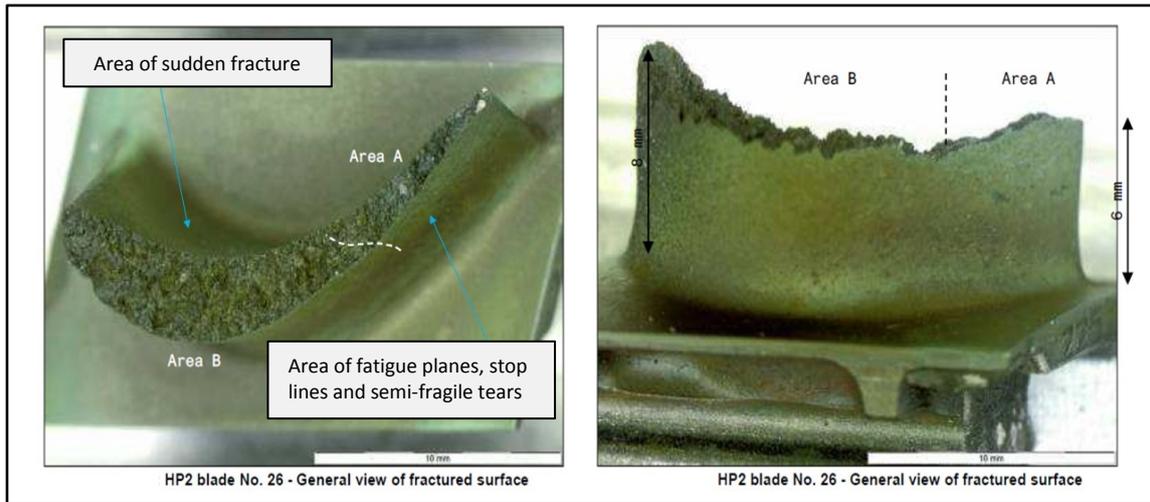
Figure 4: Blade No. 26 fracture surface examination

Inspection of the fracture surface revealed two distinct regions nominated as area A and area B. Area B included the leading edge and accounted for approximately 83 per cent of the fracture surface. Area A included the trailing edge and covered the remaining 17 per cent of the fracture surface (Figure 4).

The blade No. 26 area B fracture surface was typical of overstress and sudden fracture. Several isolated areas of fatigue crack propagation near the trailing edge of the blade (Area A) were noted; however, the origin could not be determined. There was no evidence of blade creep or sign of foreign object damage.

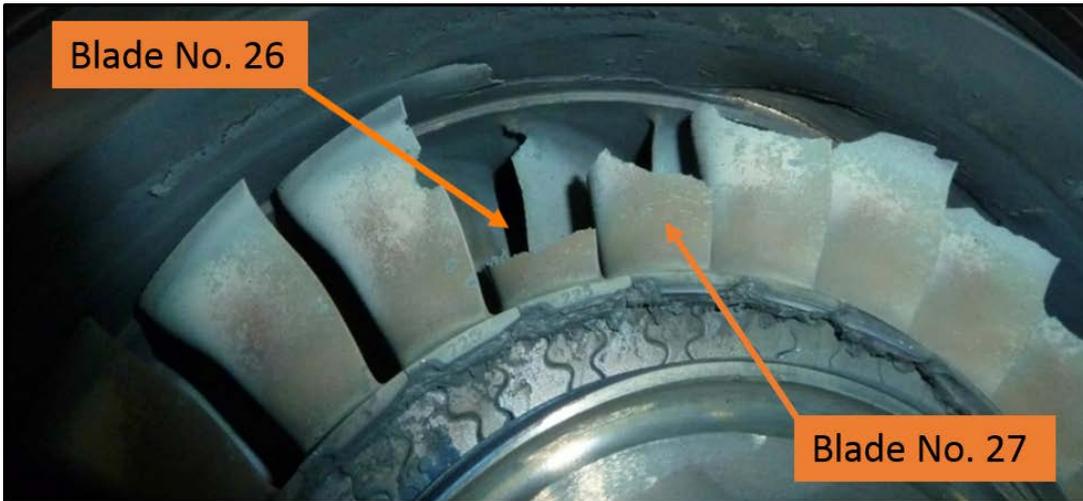
Figure 5: Blade No. 26 and damage to the adjacent blades

The examination of Module 3 revealed significant damage in the turbine area. This included fracture of the No. 26 blade of the GG high pressure turbine assembly second stage wheel (HP2) with resulting impact damage to, and loss of material from a number of adjacent blades. The GG turbine rear bearing also exhibited signs of significant damage associated with heavy rubbing on the races and flattening of the bearing rollers.

The blade No. 27 fracture surface was consistent with static overstress resulting from the impact of blade No. 26. This phenomenon also explained the damage observed on a number of the other blades. No significant metallurgical discrepancies were identified between the blades that were examined.

The fractured No. 26 blade and adjacent damaged blades are shown in Figure 5.
