In-flight engine failure involving Sikorsky S-76C helicopter, VH-EXU

Snapper Platform, Bass Strait (74 km east of Longford, Victoria) | 11 July 2013

ATSB Transport Safety Report
Aviation Occurrence Investigation
AO-2013-124
Final – 20 October 2016

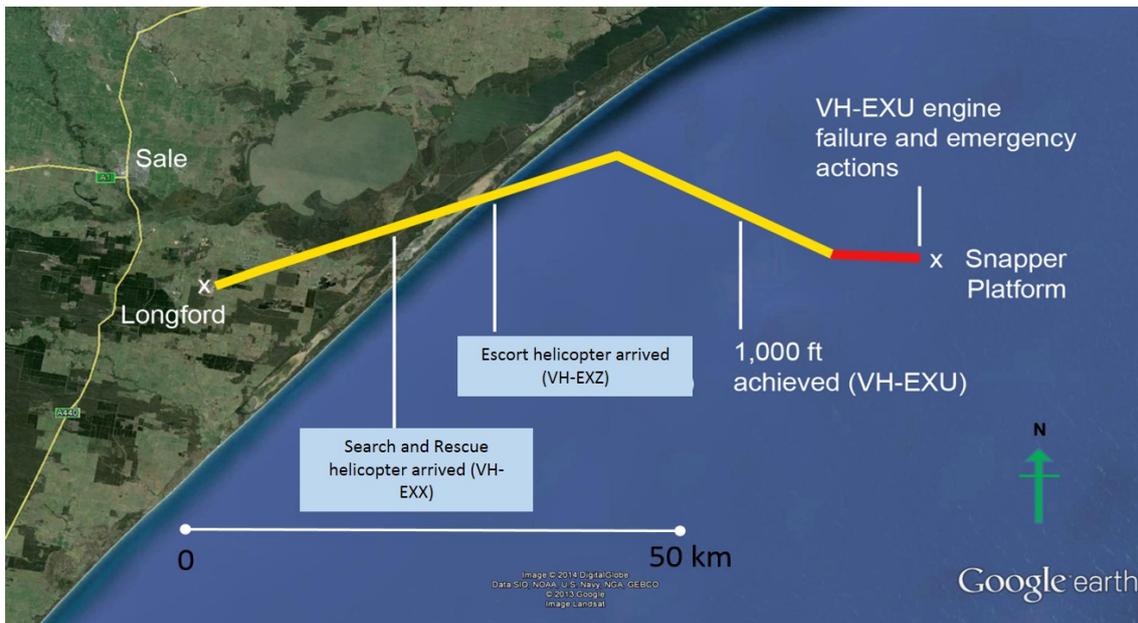
Figure 1: Approximate flight track from Snapper platform to the operator's heliport at Longford

As part of their ongoing checks, the flight crew determined that the available fuel quantity in the tank that was feeding the left engine was approaching a low level as the helicopter approached the coastline. In response, the crew activated the cross-feed function to supply fuel from the right tank to the operating left engine. This ensured adequate reserves for the remainder of the flight to Longford. A depiction of the approximate flight track is provided in Figure 1.

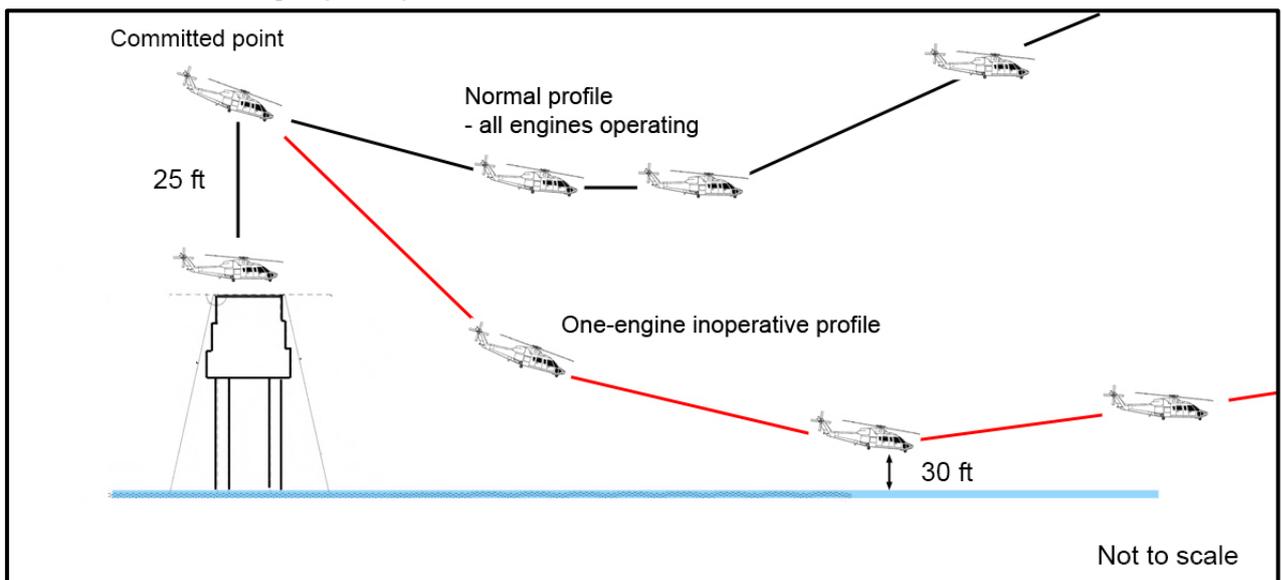
Figure 7: Elevated helideck profile showing a representation of the operator’s Category B departure with all engines operating (in black) and an estimation of the departure profile for the occurrence flight (in red)

Figure 7 provides a representation of the operator’s Category B departure from an offshore platform with all engines operating and an estimation of EXU’s profile following the engine failure.
