Annual Safety Review 2016

Benefits of Using Drones at Aircraft Accident Sites

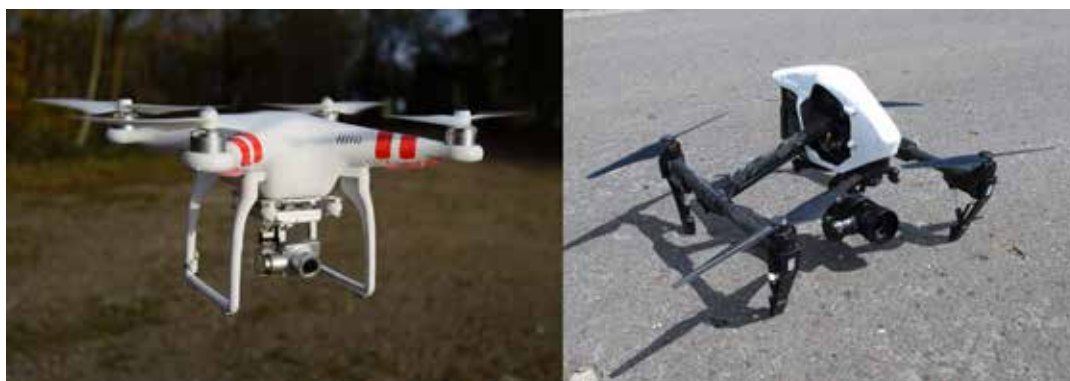
Figure 2

DJI Phantom 2 Vision Plus (left) and DJI Inspire Pro (right)

The photogrammetry software the AAIB purchased was called Pix4Dmapper Pro. This provided some good photogrammetry results using the drone. In September 2015 the AAIB upgraded to the DJI Inspire Pro drone (Figure 2, right), which can operate in winds up to 20 kt and has a higher quality camera that can stream high-definition (HD) video to two tablet devices. This model is also available with dual controls for the pilot and camera operator.

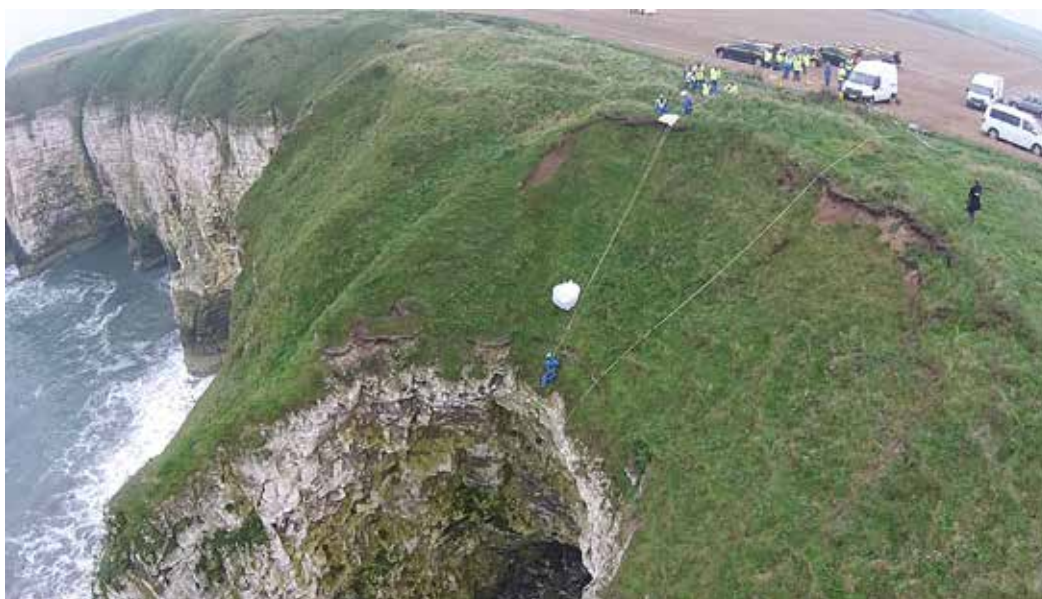
Figure 3

The AAIB's Phantom 2 Vision Plus being used to supervise the recovery of wreckage from a Jet Ranger helicopter that crashed in the sea below the cliffs

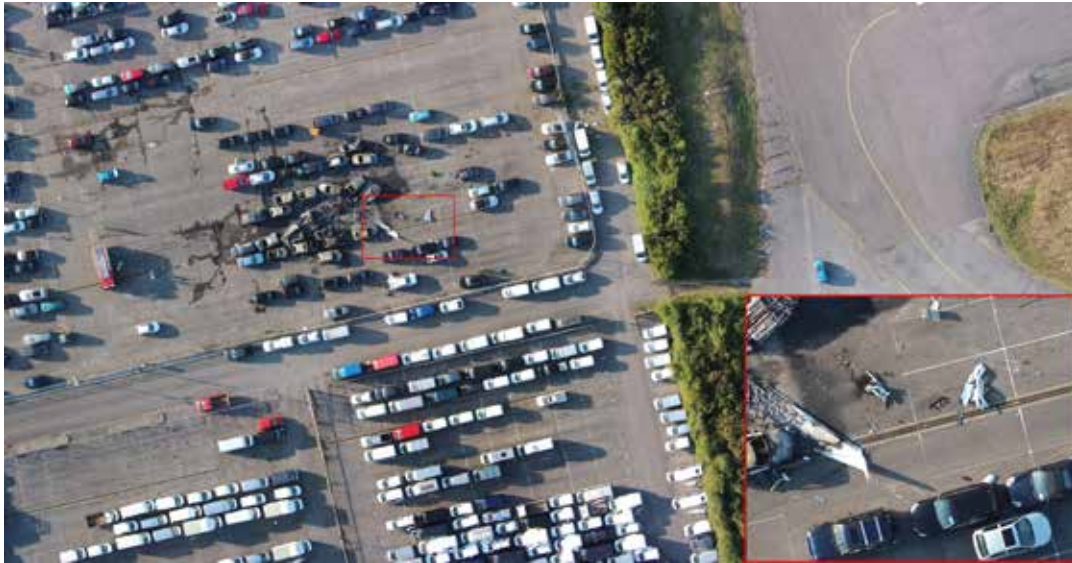
Pix4D orthomosaic generated from 59 overlapping images taken with a Phantom 2 Vision Plus from a height of 50 metres (a digitally zoomed-in section of this orthomosaic is shown in the lower right corner)

With photogrammetry software like Pix4Dmapper Pro orthomosaic images and 3D models of accident sites can be produced using drone imagery. An orthomosaic is an image that is composed of multiple overhead images and is corrected for both perspective and scale, which means that it has the same lack of distortion as a map (Figure 4). The images are obtained by pre-programming the drone to fly in a grid pattern and to automatically take a series of overlapping shots with the camera pointing 90° down. The total flight time to capture the 59 images used to create Figure 4 was 9 minutes using our Phantom 2 Vision Plus. The processing time using a typical PC took about 2 hours but it can take longer for larger projects.

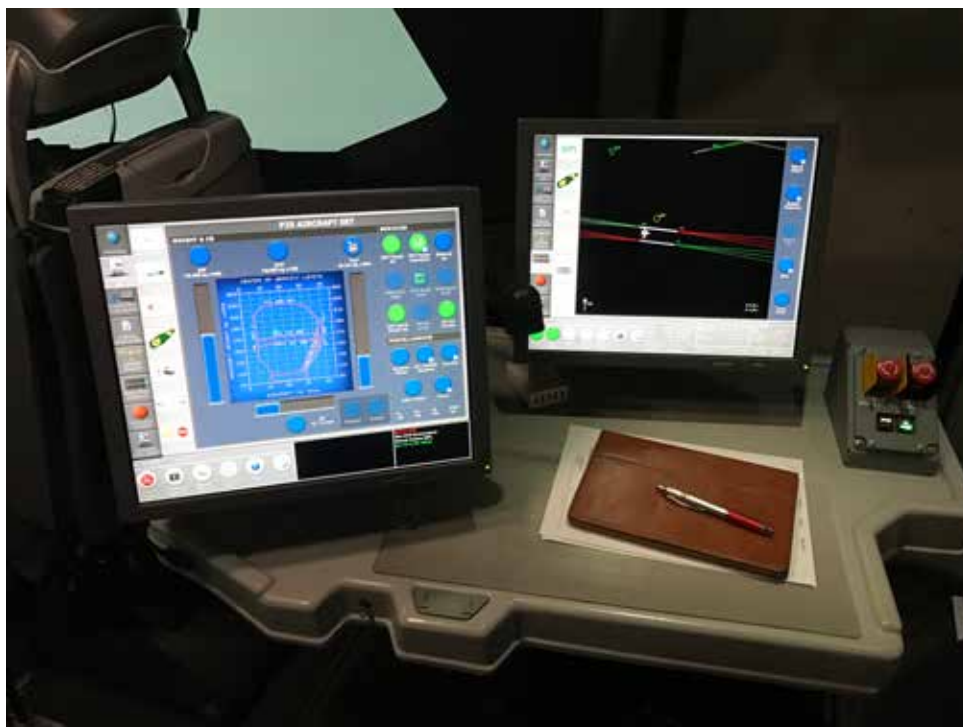
Figure 2

Instructor Operating Station

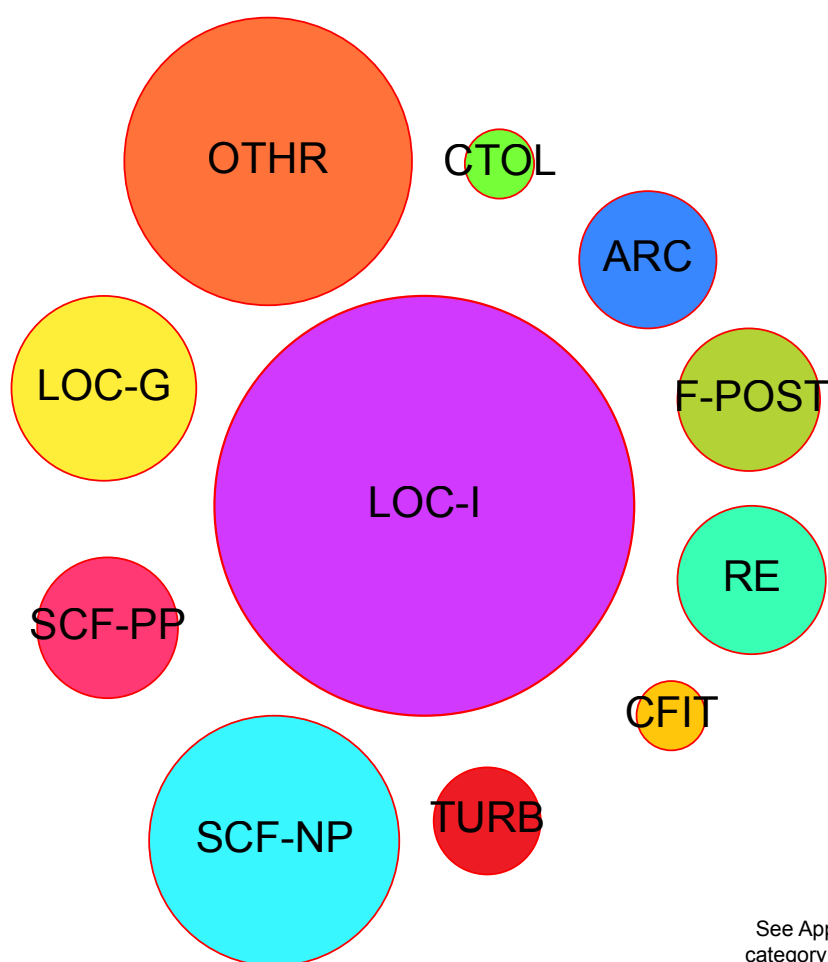
Factors for field investigations reported on by AAIB in 2016

In 2016 the AAIB reported on 36 field investigations, 17 of which involved fatal accidents in the UK and 19 were non-fatal accidents or serious incidents. The analysis of the CICTT factors for each of these reveals that the major factor in fatal accidents reported on in 2016 was LOC-I. Of note, two fatal accidents were attributed to medical incapacitation (MED) and one was caused by a catastrophic structural failure recorded under SCF-NP.

The 19 non-fatal field investigations reported in 2016 concerned mostly serious incidents to commercial air transport (CAT) aircraft. The majority of CAT serious incidents were attributed to system/component failure or malfunction (SCF-NP) followed by power plant failure or malfunction (SCF-PP), runway excursion (RE) and abnormal runway contact (ARC). However in general aviation (GA), the statistics show the most prolific cause of accidents and serious incidents was again LOC-I.

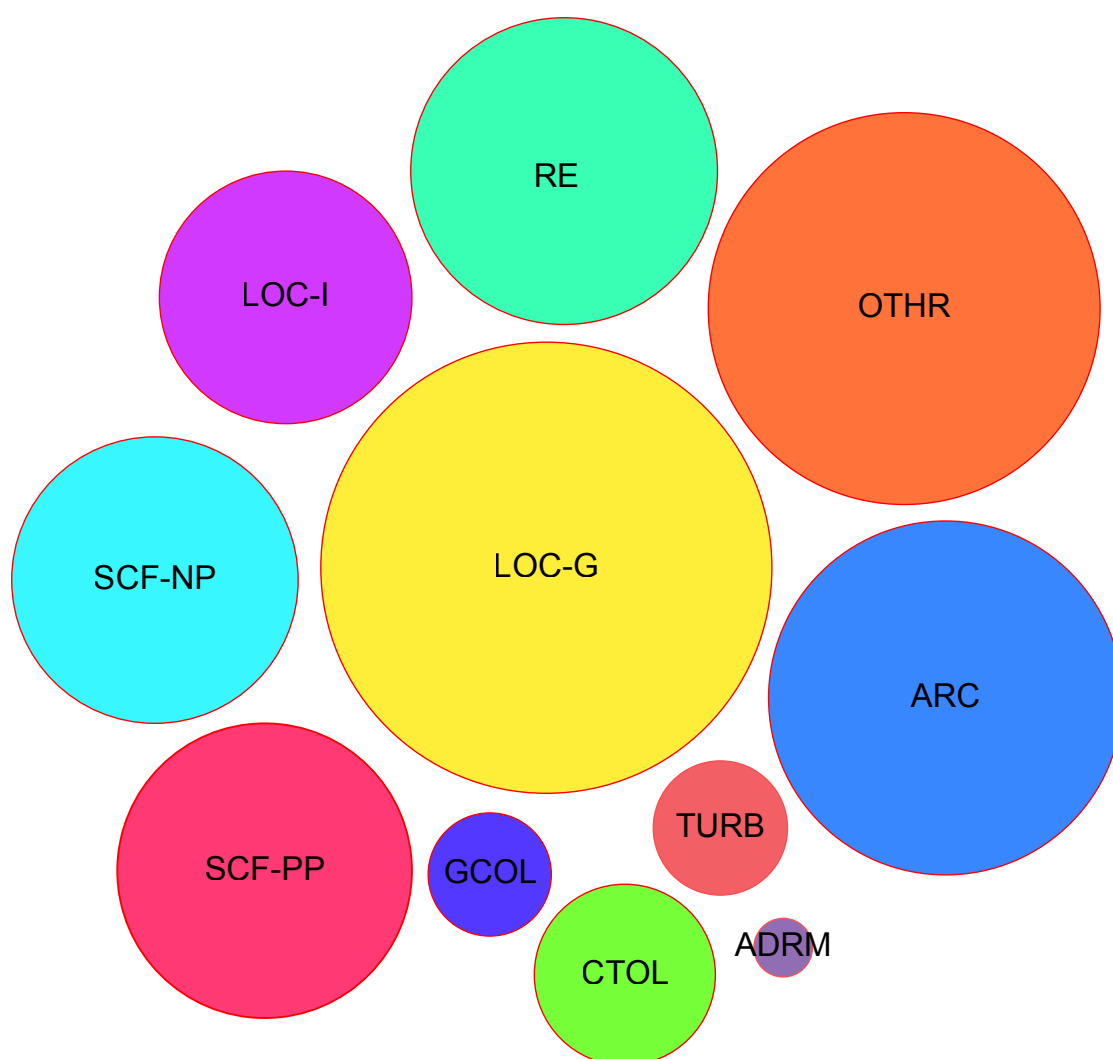
Factors for correspondence investigations reported on by AAIB in 2016

Correspondence investigations are usually conducted on non-fatal accidents on GA aircraft and to some serious incidents on CAT aircraft. The factors in that the majority of these reports were classified as loss of control on the ground (LOC-G), abnormal runway contact (ARC) and powerplant failure (SCF-PP).
