# ***SAFETY ALERT***

## **Helicopter Landing Sites: Free from Debris**

***Foreign object debris can foul rotor systems and cause damage***

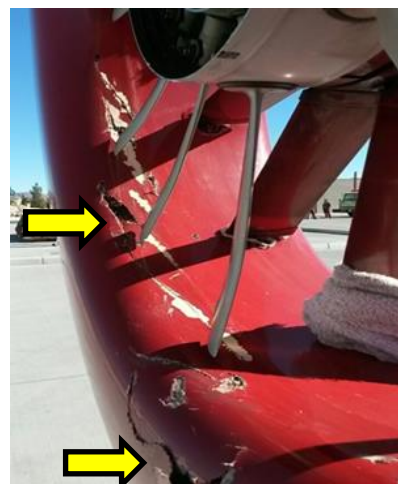
- The pilot of an Airbus (formerly Eurocopter) EC135 P2+ helicopter reported that, while landing at a public safety training center, he felt the helicopter shudder unexpectedly. The pilot immediately landed the helicopter without further incident. A postflight examination revealed that a towel had been ingested into the fenestron (see figures 1 and 2). The towel ingestion resulted in separation of the fenestron hub cover, which was subsequently ingested, substantially damaging the helicopter. The pilot reported that the towel came from an unsecured storage container near the landing site. ([GAA16LA056](#))

**Figure 2.** Lower fenestron housing.

- When choosing a landing site, avoid areas close to construction activities and trash storage. Consider the effects of main rotor system downwash and upwash on FOD migration when selecting a landing site, based on the site conditions and the size of the helicopter.

- Ask available personnel to conduct a sweep of the landing site for FOD that could affect the helicopter. If personnel are not available, visually scan for FOD on the landing site while conducting your high and low reconnaissance before you land. If the conditions permit, check for FOD while conducting your ground reconnaissance before you take off.

- Have personnel at the landing site remove or secure any headgear (such as helmets, hats, and knit caps). Ensure any additional clothing, gear, and equipment items are secured and kept clear of the main and tail rotor systems.
